# 1956 Mercedes-Benz Type W180 220S Ponton Fuel Pump Reconditioning

Anthony Tugwell / [AnthonyT@Mail.com](mailto:AnthonyT@Mail.com) / South Australia

## Introduction

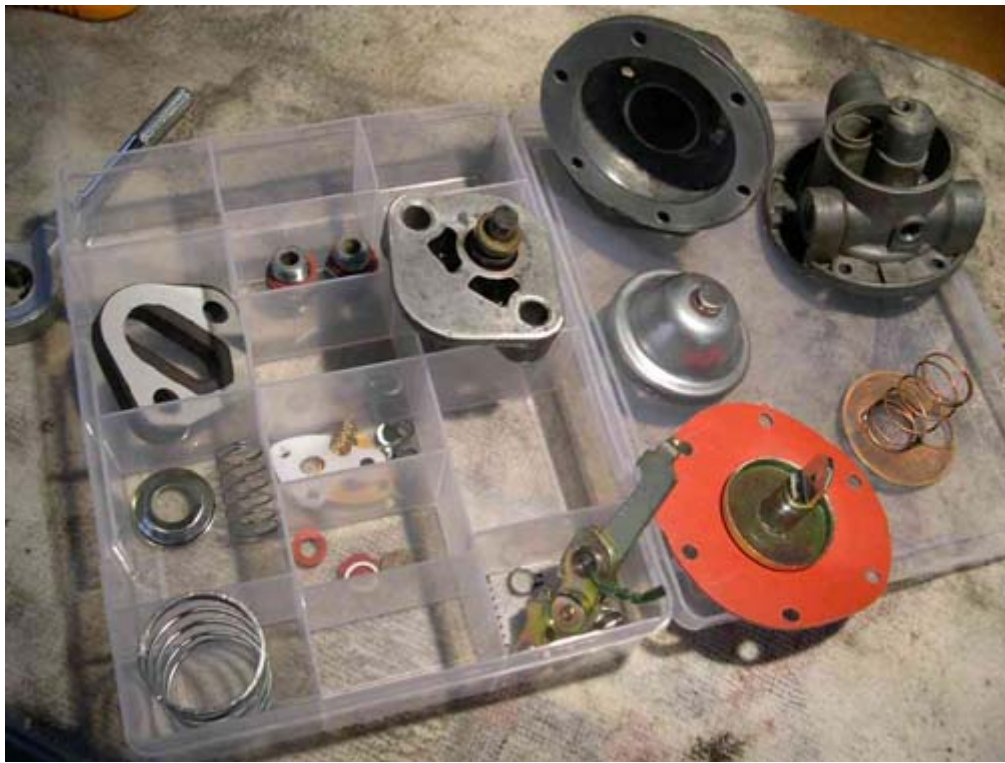
New and reconditioned items prior to re-assembly

Additionally, I needed to order one more gasket from Mercedes-Benz (item 39, or 37) and one gasket (item 42) which fits against the engine.

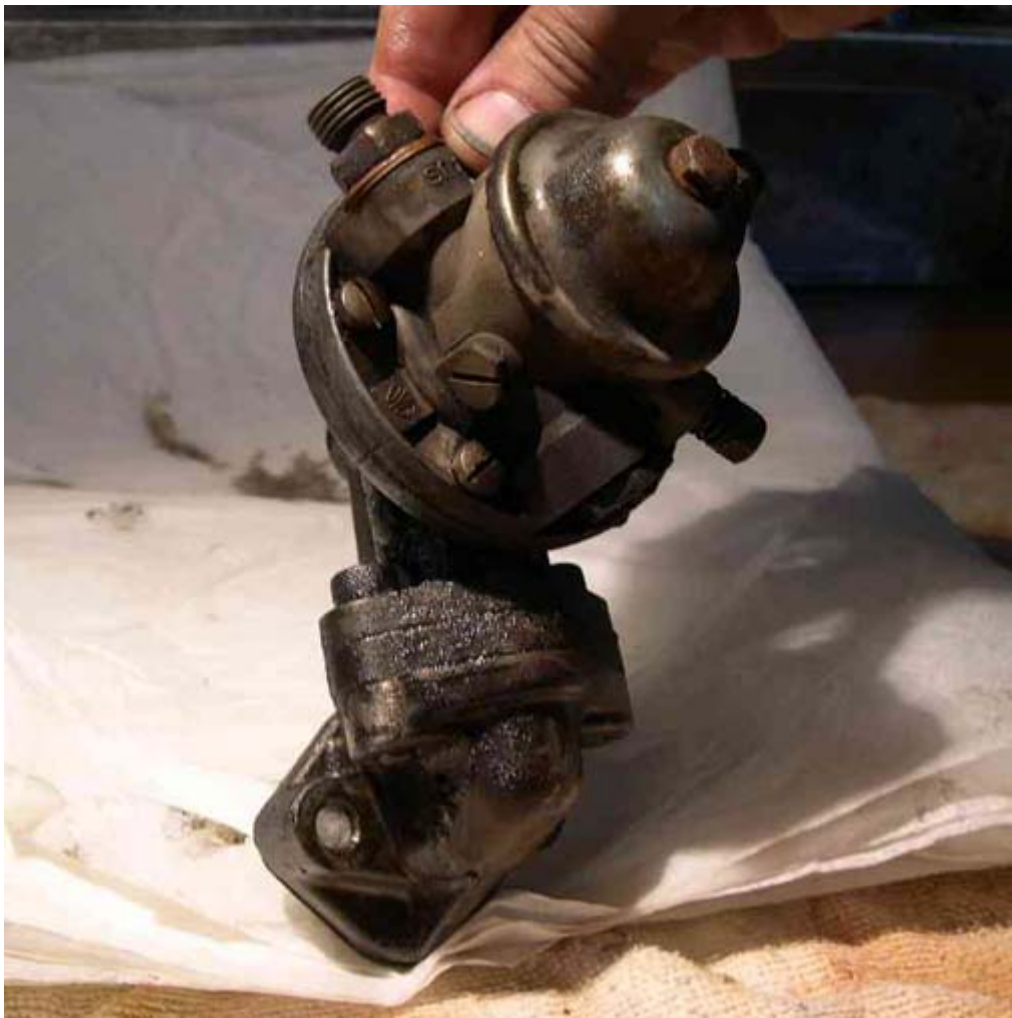
Fuel pump and engine bracket just removed from car

The fuel pump is attached to the front-left side of the engine, down below the distributor, via a right-angled bracket which houses the cam follower. Refer to [Doug Broome's article](#) and Håkan Johansson on this cam follower. As Doug says, it is best to remove the pump and bracket together. After disconnecting intake and exit fuel lines, (and plugging them as necessary with a rag or similar), remove the two Allen (hex) head bolts attaching straight into the side of the engine. The pump will come free.

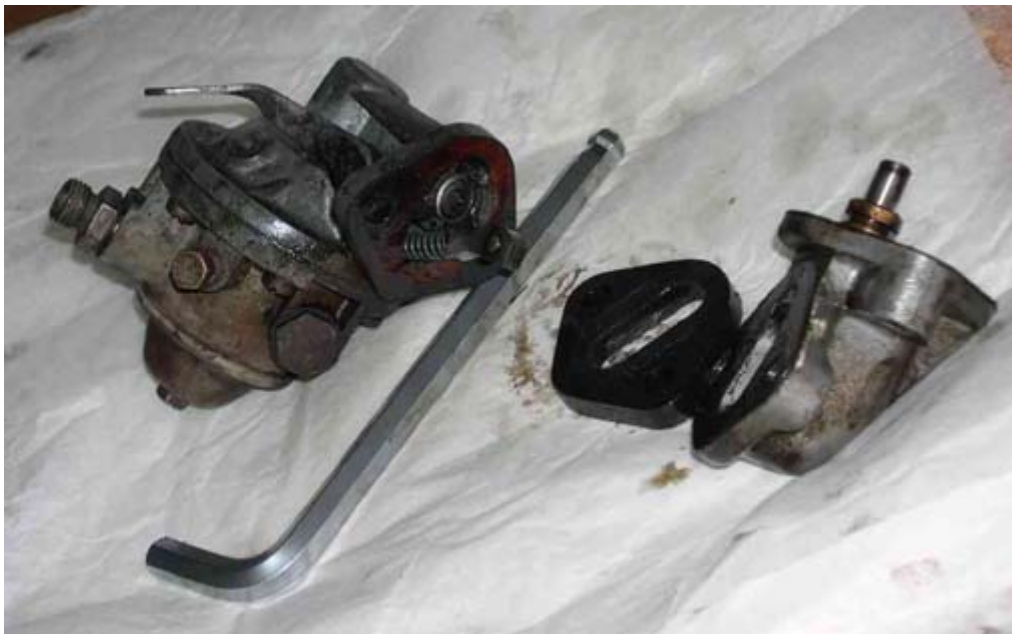
Pump and bracket separated &MDASH; Note cam follower at top of bracket

On your bench, remove the engine bracket by undoing the two similar Allen (hex) head bolts attaching to the pump. You will now see the diaphragm operating lever. Refer to photos.

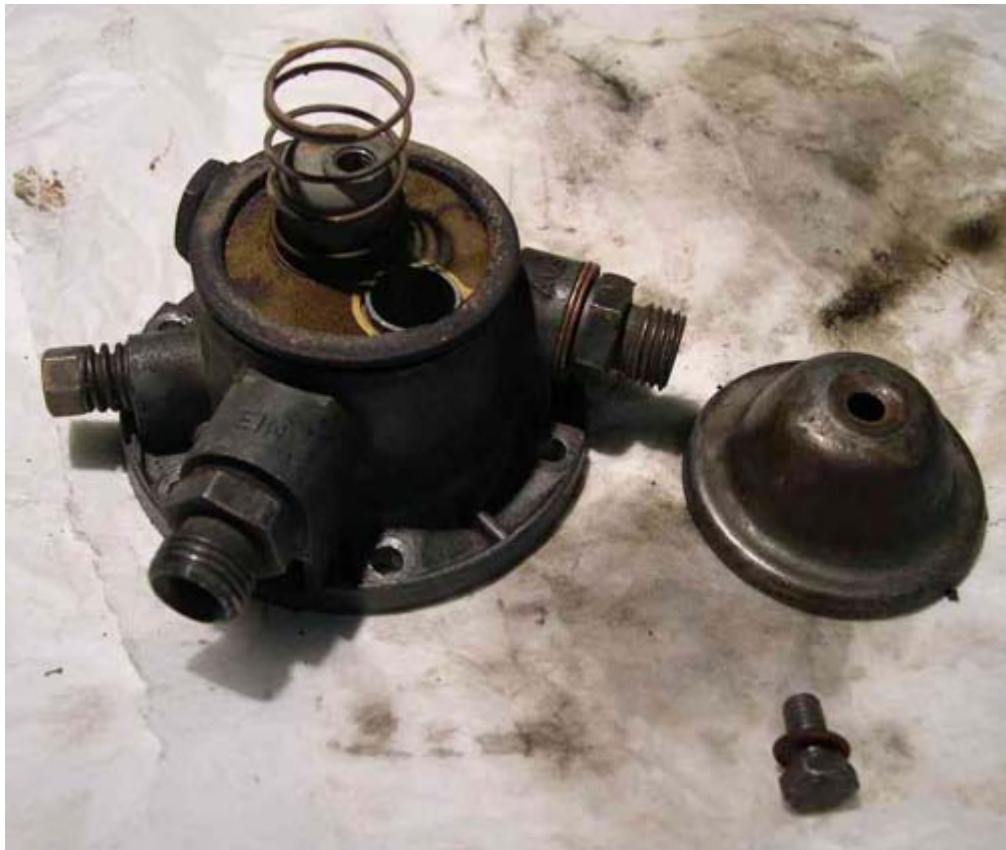
Filter cap removed showing original filter and spring inside

Refer to the [Ray Ilich article](#) for disassembly. However you also need to remove the pump cover screw and gasket, take off the cover and carefully remove the copper filter and spring

inside. These will be replaced.

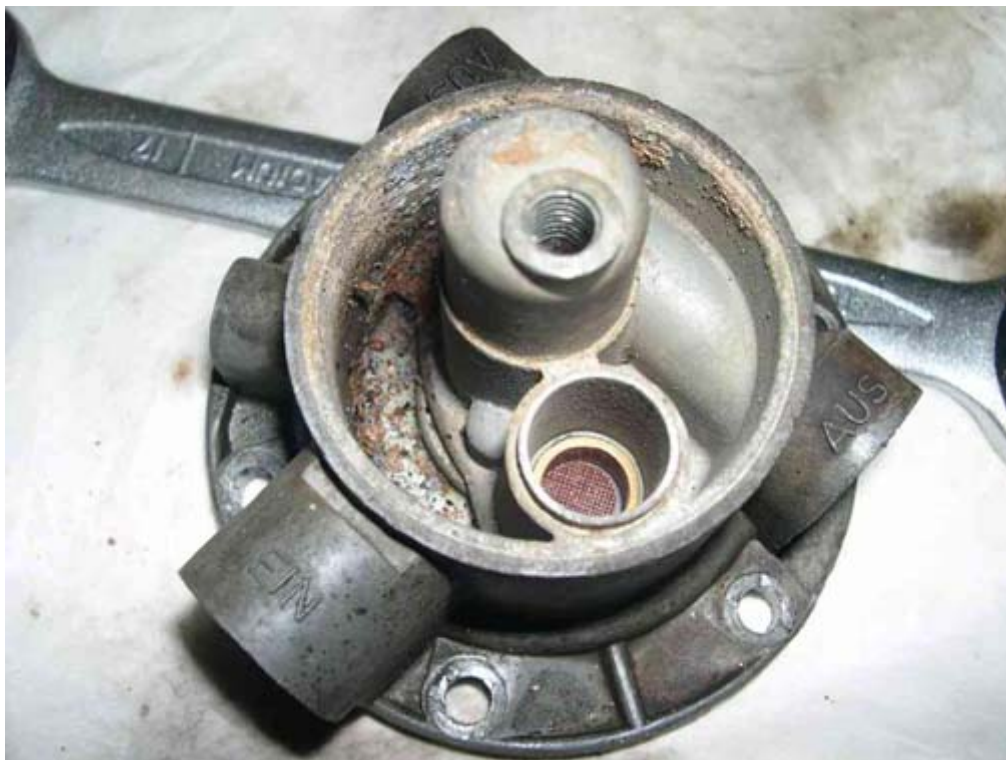
With filter removed, a lot of debris is visible

Clean up everything with a suitable cleaner. I used carburetor cleaner from a spray can which worked quite well. However there are all sorts of little nooks and crannies in and on the main body of the pump which need a bit of work; cotton buds and more carb cleaner should suffice.

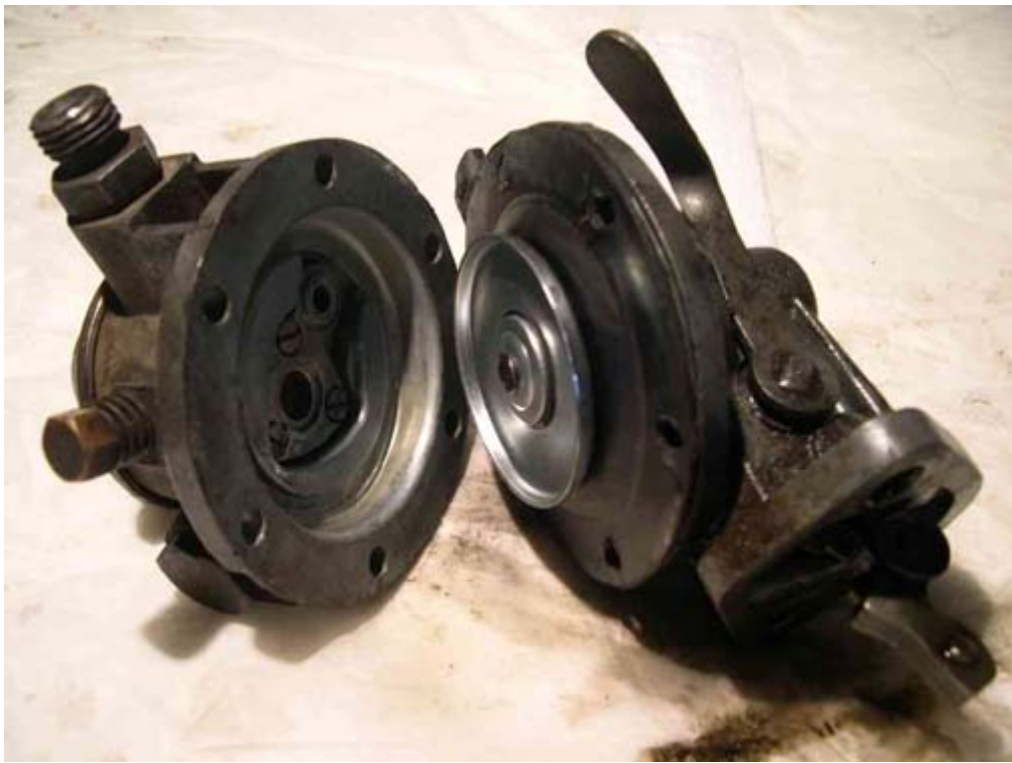
Pump body separated showing original diaphragm

2. Carefully use a thread die on the above equivalent male items.
3. Carefully clean up the exteriors, bolt flats and the like of fuel fittings, water drain plug, etc. using fine wet or dry emery paper.
4. As Doug and Håkan have noted, carefully rub the mating faces of the two halves of the pump with a fine emery paper, on a flat block if you have one. This is where the diaphragm is held.

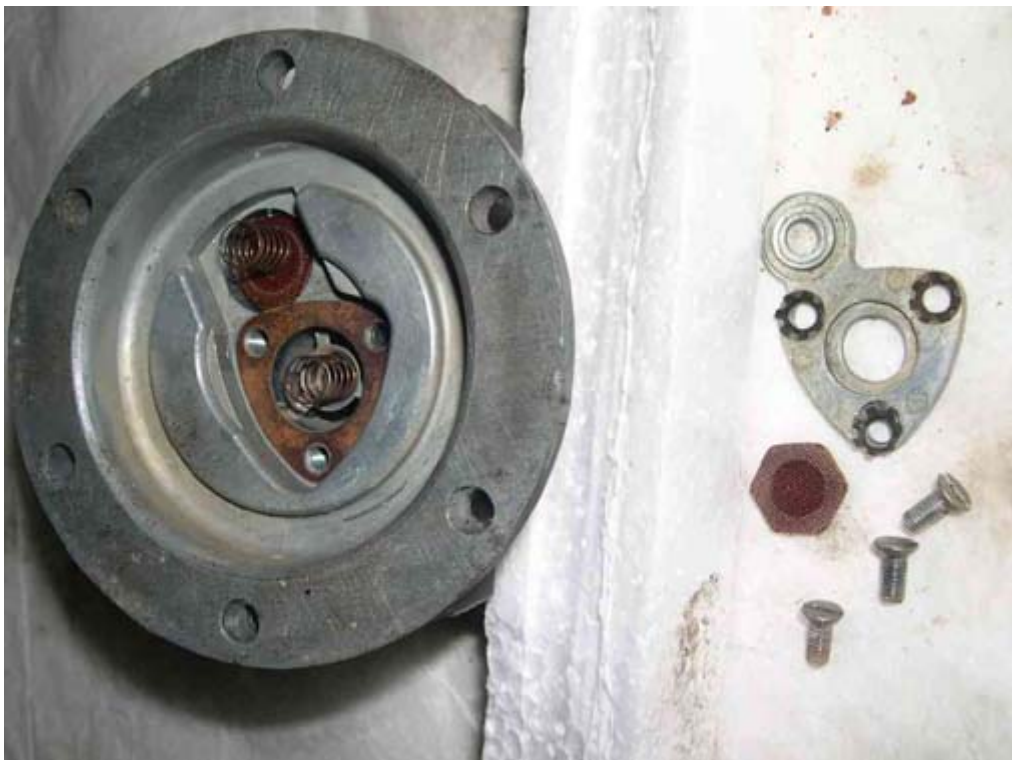
Original valves seemed to be in fair condition

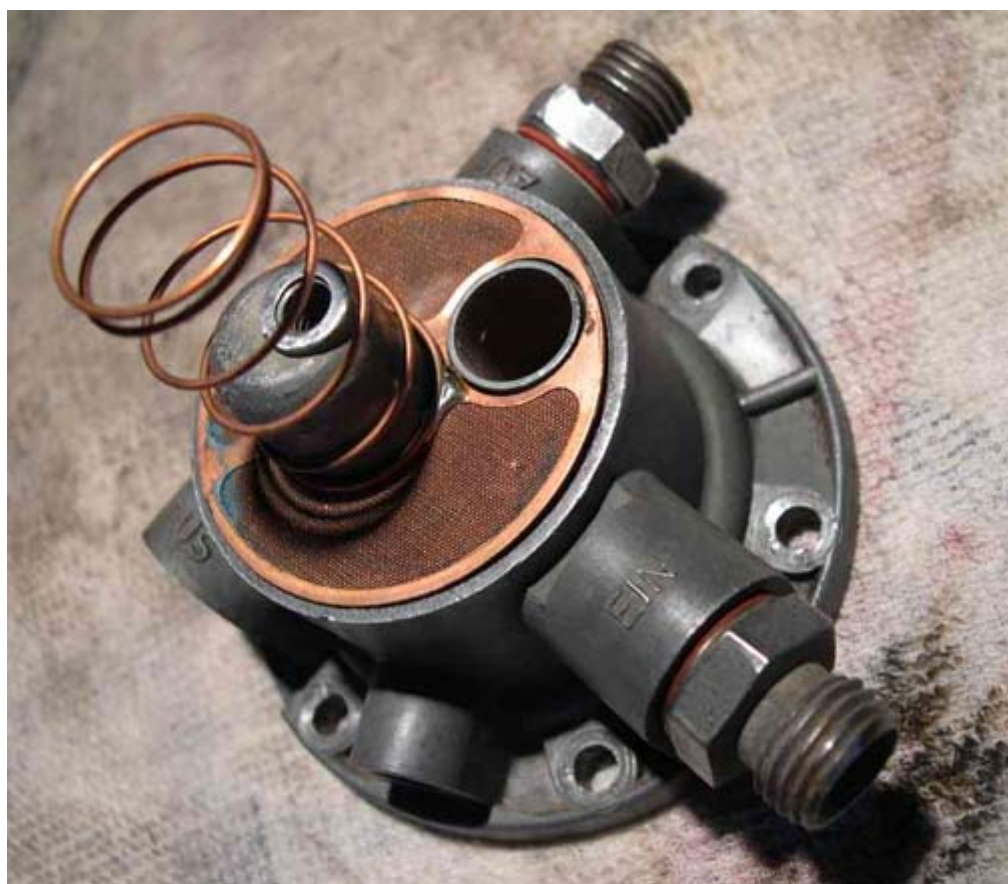
New filter and spring in cleaned up housing

Refer to [Ray Ilich's article](#) but bear in mind the extra steps outlined above. Step 8 should include replacing the copper filter and spring, (a bit of care here), also the cover gasket and then replacing the pump cover, which Ray refers to as a bell cover.

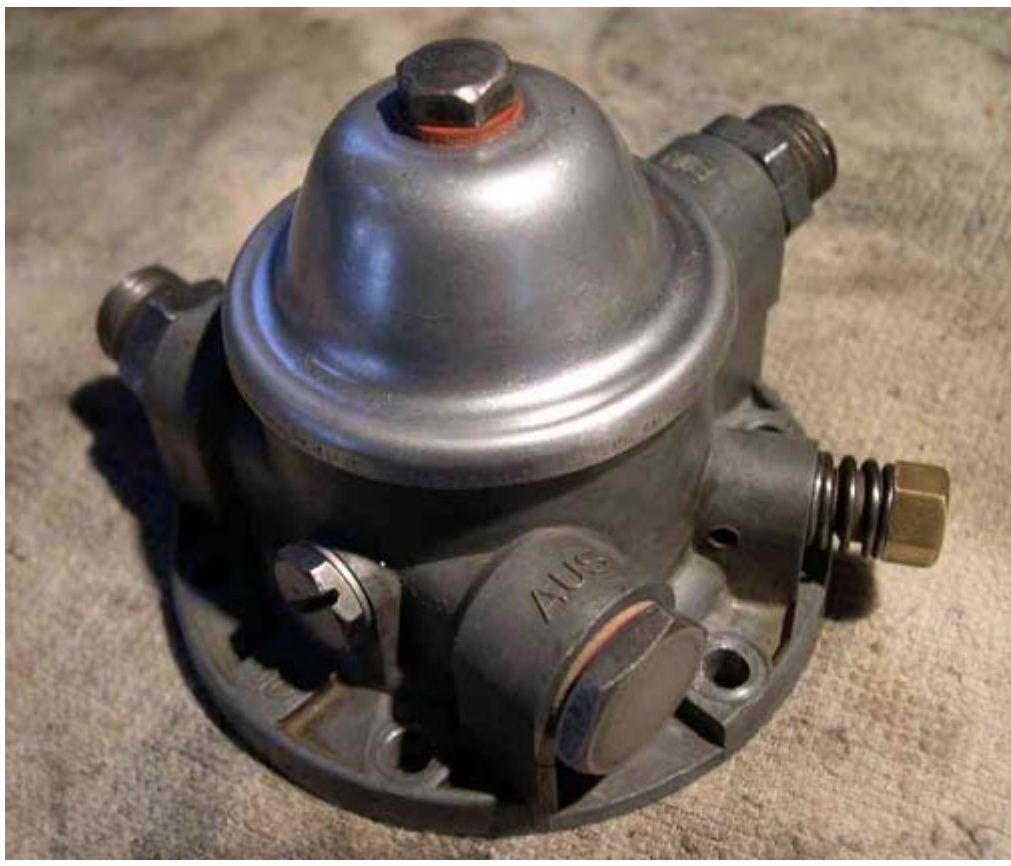
Filter and refinished cap in place

Having cleaned up all parts, I saw that the pump cover, (item 1) was unlikely to buff up to a reasonable appearance. I found a "soft chrome" oil paint and spray-coated it carefully with two coats. The result was good and cosmetically I think it looks pretty correct. Refer to reassembly photos.

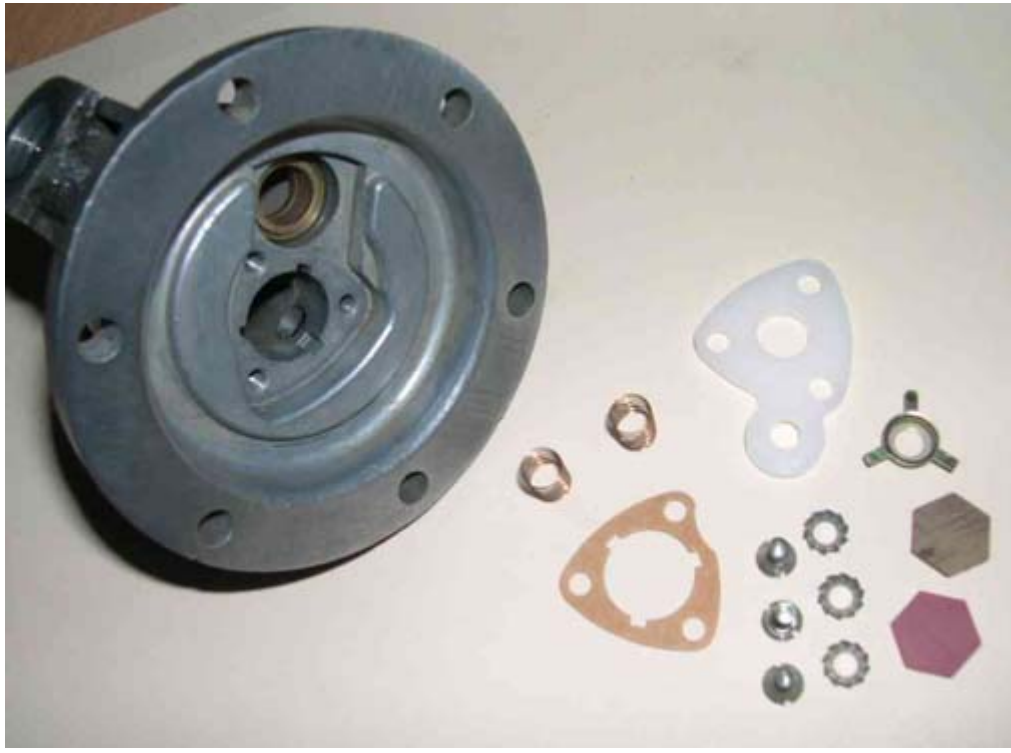
New valve parts showing hard white plastic item 15

Then as part of Ray's step 8, turn the housing over to replace valves. Refer to my photos.  
Note: I actually did the valves first and then the filter, etc. It does not matter which is done first.

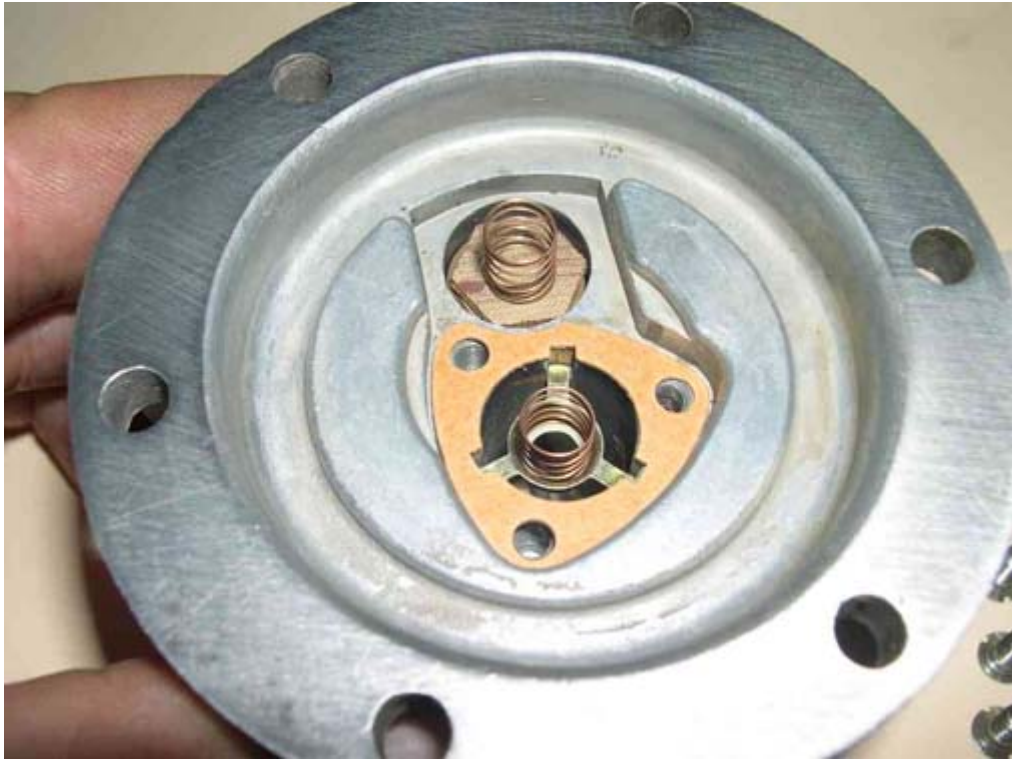
Valve springs, valves and gasket in place

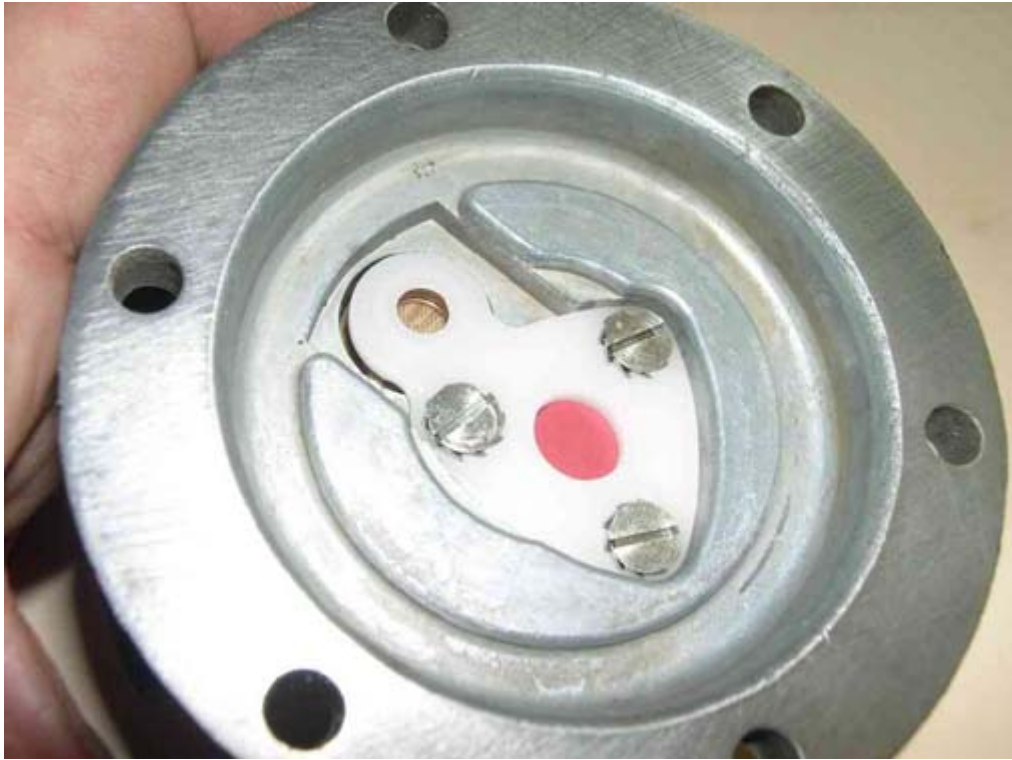
Valves completed

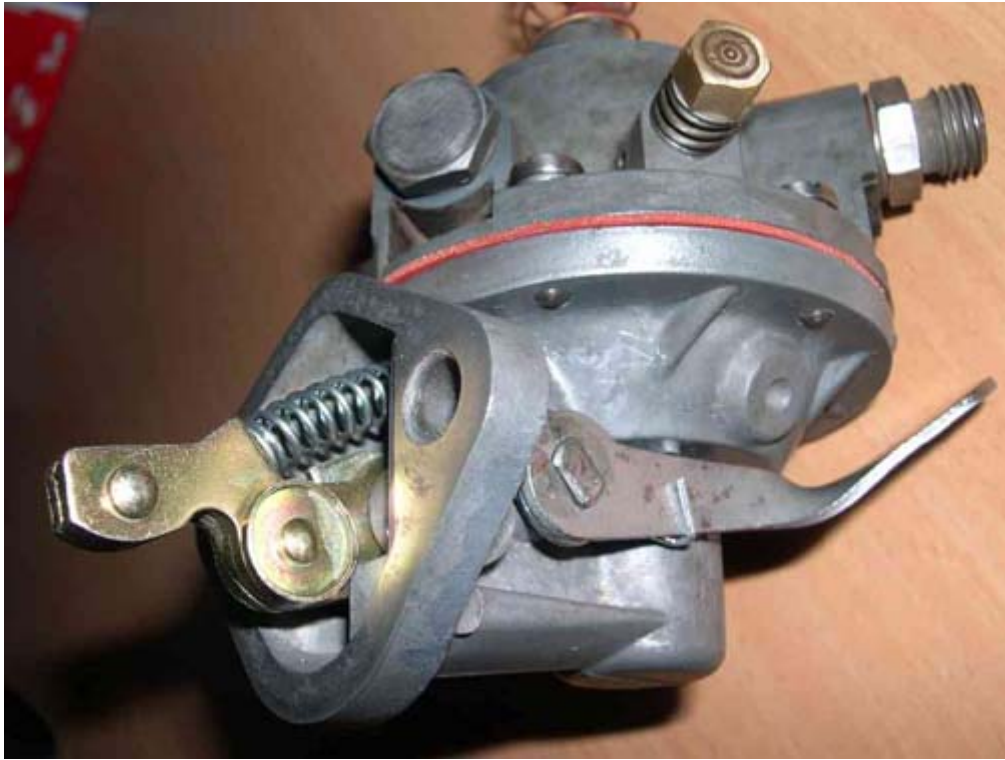
This view shows new diaphragm lever (cadmium colour, left) and priming lever extending right

Step 10 is then amended to include replacement with a new lever assembly and lever pivot, (but not spring at this point). The lever pivot is a hand-pressure press fit. It IS a bit of a juggle to get the lever engaged with the diaphragm locating lug but you will get there, as long as you leave the 6 diaphragm bolts loose.

Tighten the 6 bolts carefully and alternating cross-wise in pairs. Check diaphragm movement with the lever. When correct, maneuver the spring (item 8) into position.

Re-install the priming lever assembly, its new securing circlip and new spring (items 2 & 3). For me this was tricky as the spring is awkward to fit. I do not have any special hints except it might help to try to fit the spring while the lever is slightly out of final position. Then press it home and fit the circlip. Try the priming lever's cam operation against the diaphragm lever. You should hear suction through the valves and fuel inlet/outlet.

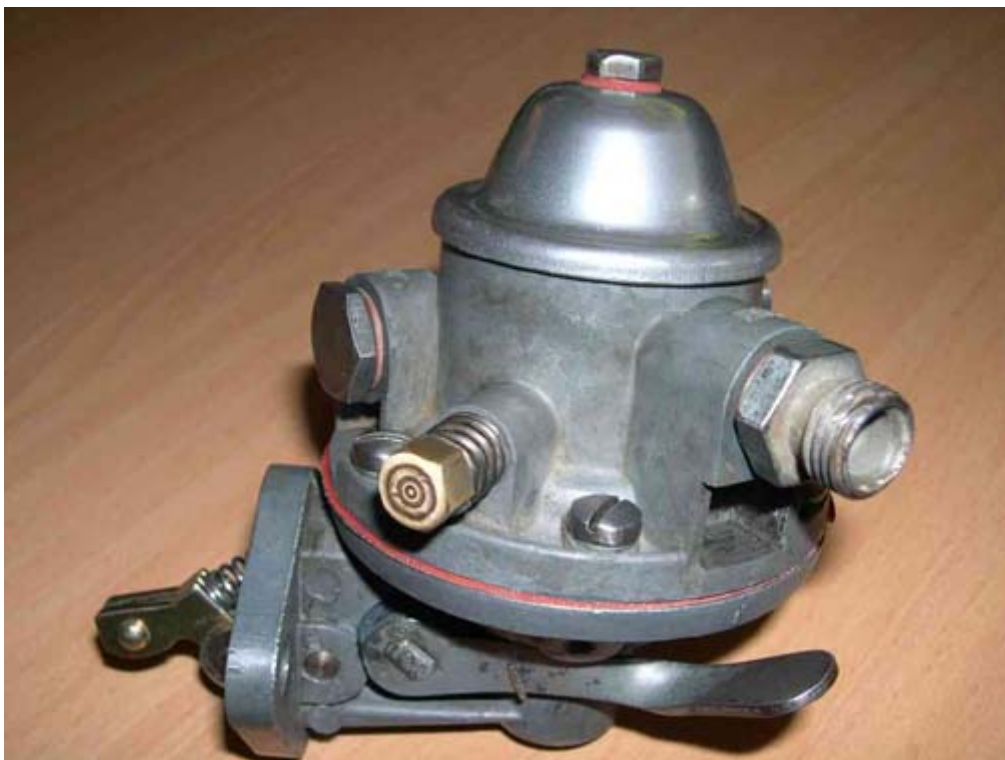
Completed fuel pump

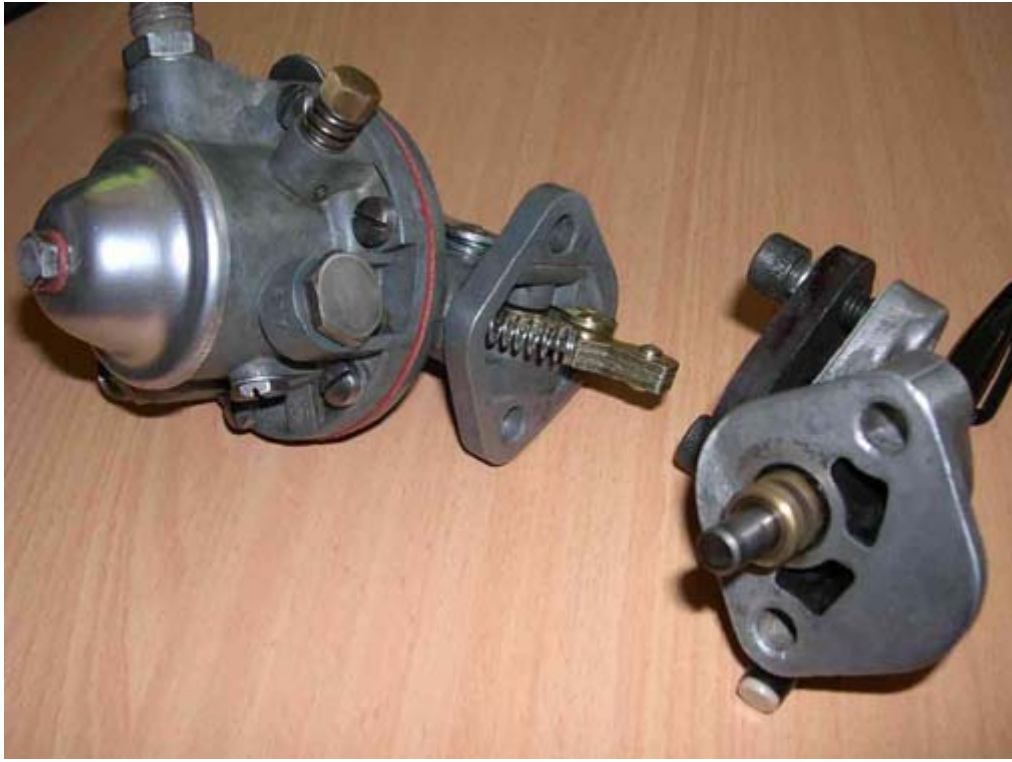
Pump and engine bracket before bolting up

Step 13 should be done on the bench not on the engine. That way you can easily see everything going together and only afterwards attach pump and bracket to the engine.

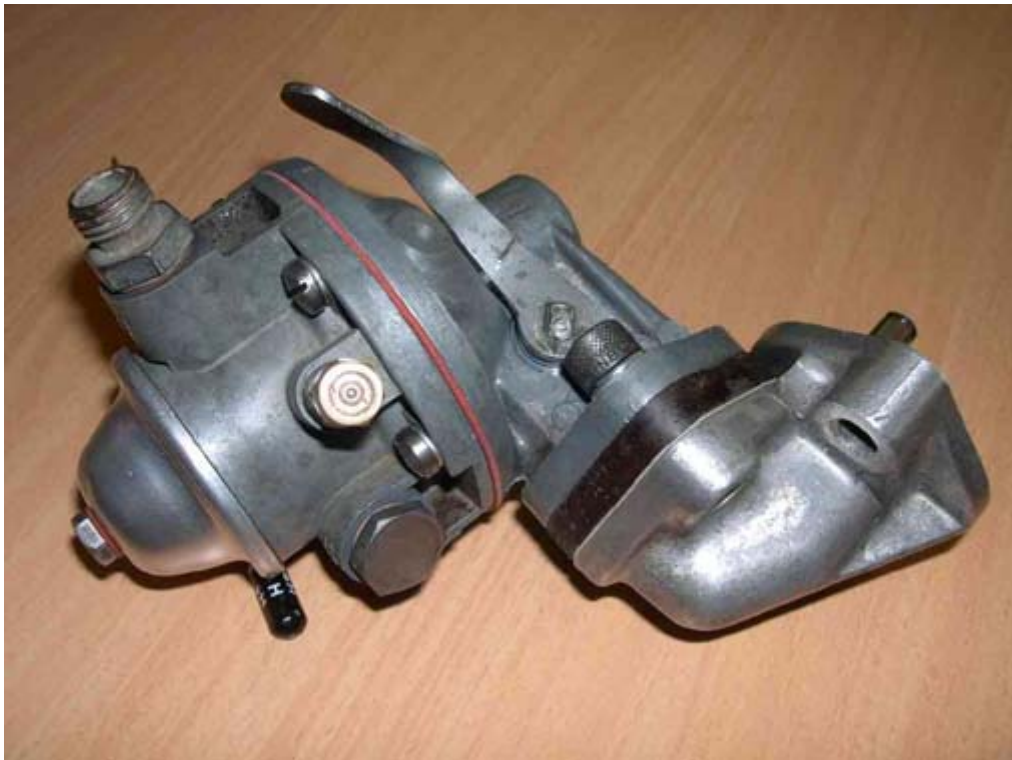
Pump and bracket together and completed
